Manhole Inspection Summary

Manhole # S49A__032MH

Insp Date: **3/23/09 3:45 PM**

Location Address: **2532 ORLEANS ST**

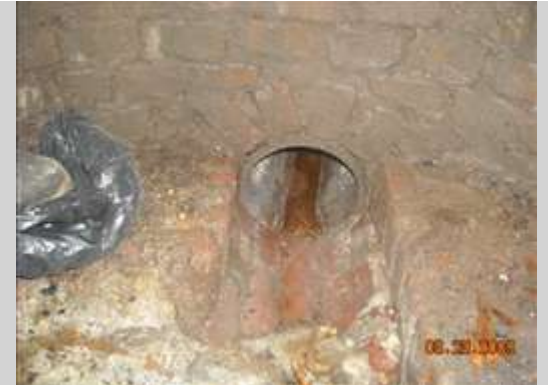
12 O'Clock Outflow

8 in. Circular Gravity Sewer
Pipe Out @ 12 O'Clock

Pipe Height: **8.4** (in.) Rod and Bar (Angled)
Pipe Material: **Clay** ☐ Pipe Lined
Invert Depth: **9.00** (ft.) Flow Characteristics: **Slow**
Deposits: ☒ None ☐ Mud ☐ **Sludgy** ☐ Debris ☐ Grease
Silt Depth: **0** (in.) Deposits Extent:
Infiltration: **None** Pipe Seal Cond: **Sound**
